Smoke and Dye-Water Observation Summary

Western Run Pilot Project - Baltimore Maryland

Dye Test
105

INSPECTION REPORT

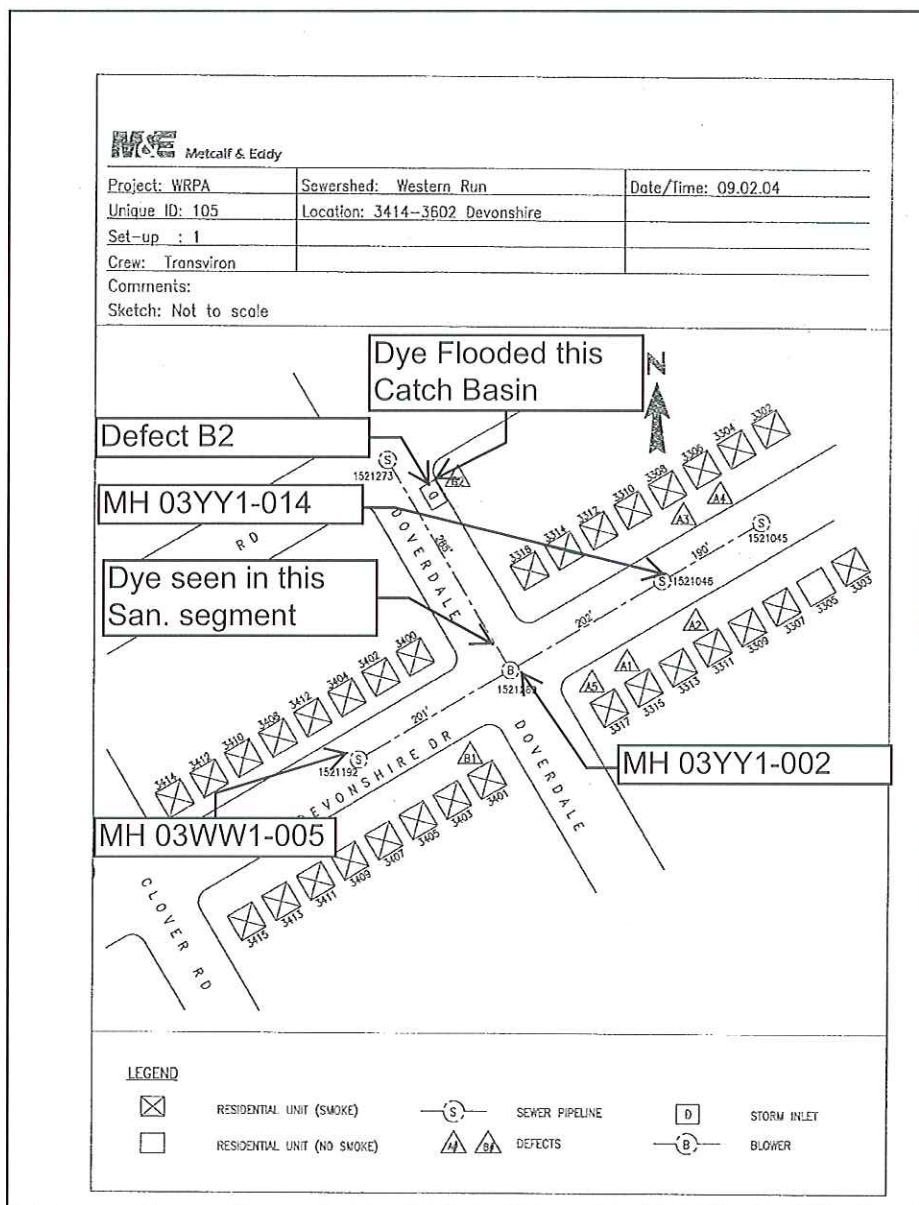
Sketch No: 105

Dye Flooded this
Catch Basin

Defect B2

Dye seen in this
San. segment

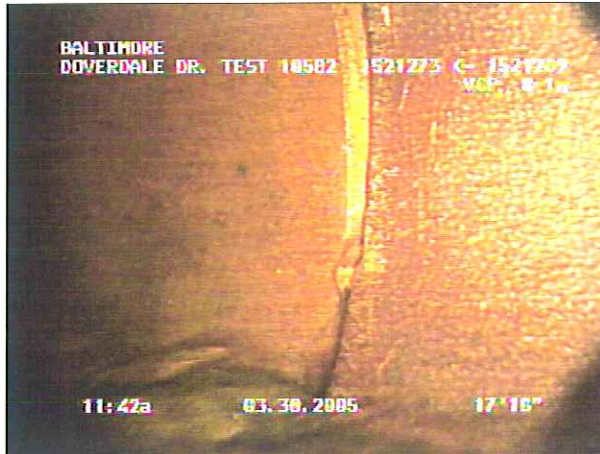
IMAGE: 26a, TAPE #: JAM 2, 00:39:57
17.81FT, Infiltration Running at joint at 04 o'clock

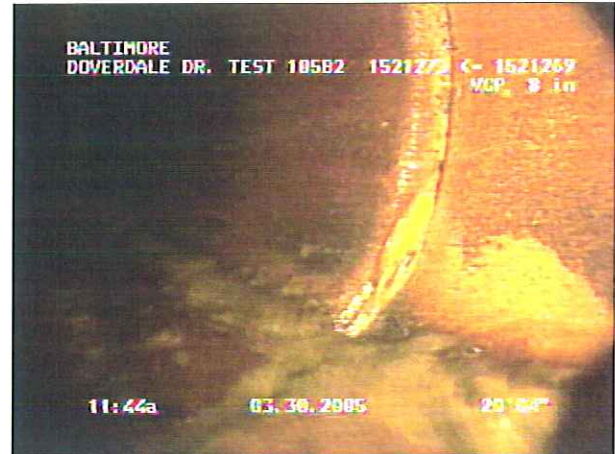
IMAGE: 27a, TAPE #: JAM 2, 00:40:36
20.32FT, Infiltration Running at joint at 04 o'clock

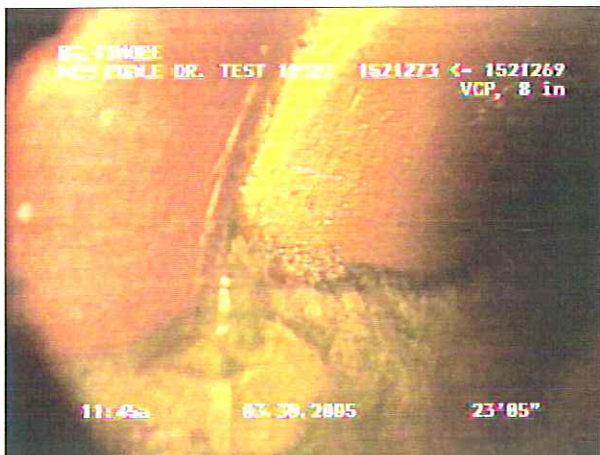
IMAGE: 28a, TAPE #: JAM 2, 00:41:31
23.44FT, Infiltration Running at joint at 08 o'clock

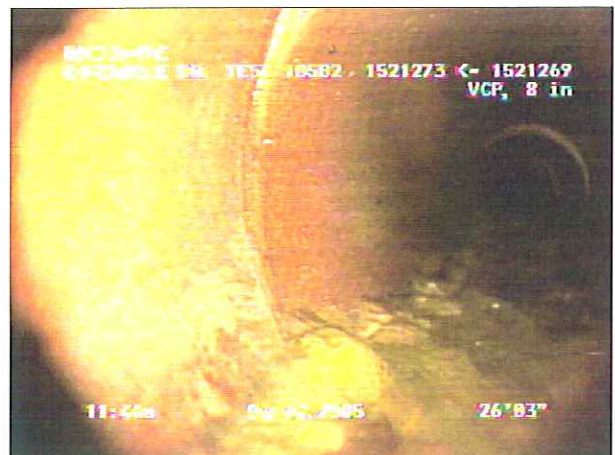
IMAGE: 29a, TAPE #: JAM 2, 00:42:11
26.26FT, Infiltration Running at joint at 08 o'clock

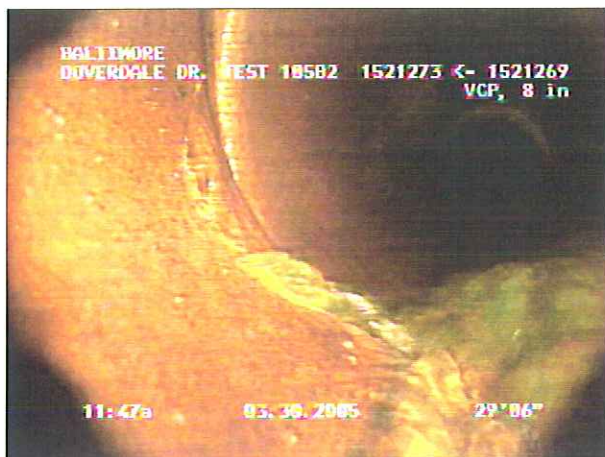
IMAGE: 30a, TAPE #: JAM 2, 00:42:50
29.48FT, Circumferential Crack at joint from 07 to 09 o'clock

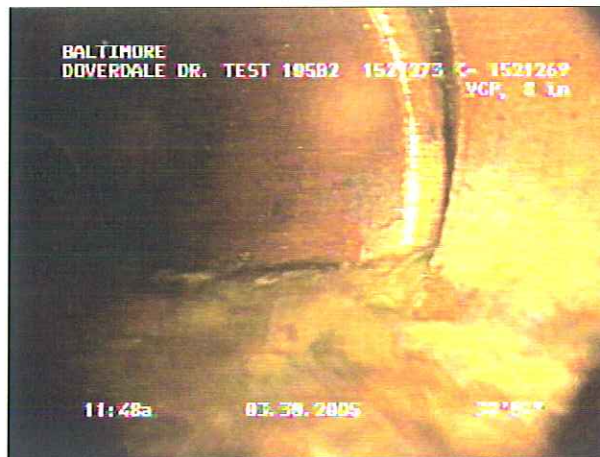
IMAGE: 32a, TAPE #: JAM 2, 00:43:28
32.6FT, Infiltration Running at joint at 02 o'clock to 8 o'clock

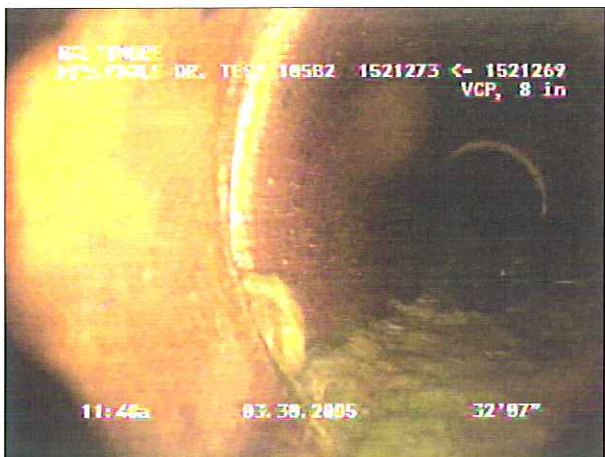
IMAGE: 32b, TAPE #: JAM 2, 00:43:28
32.6FT, Infiltration Running at joint at 02 o'clock to 8 o'clock

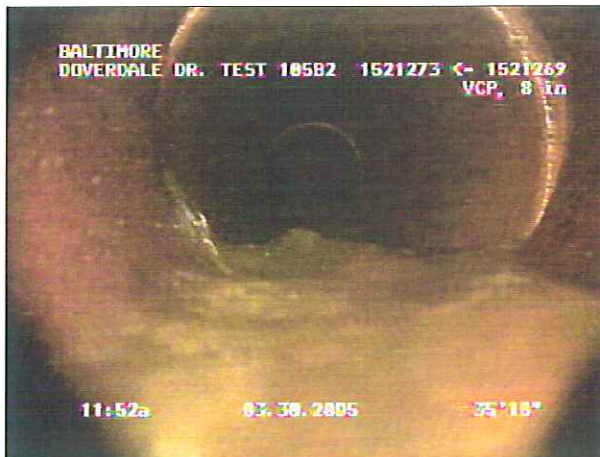
IMAGE: 33a, TAPE #: JAM 2, 00:45:01
35.82FT, Infiltration Running at joint at 08 o'clock

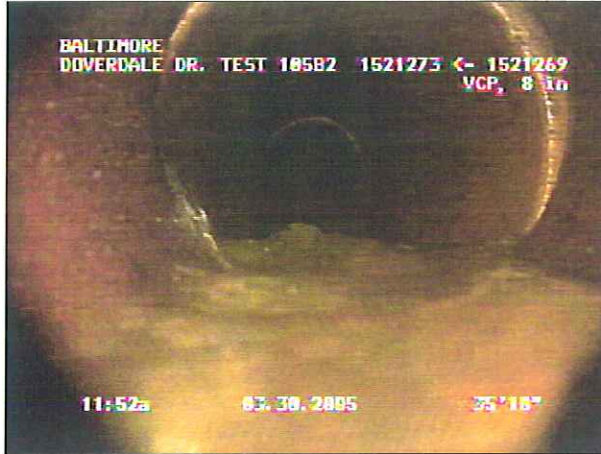
Additional Comments: RAN THE CAMERA UP 36" & GOT STUCK
ON A JOINT. NO REVERSE DONE, DID NOT SEE
REASON FOR IT. SAW WHAT WAS NEEDED TO SEE
AT

IMAGE: 6_10a, TAPE #: JAM 2, 00:46:03
36.02FT, inspection abandoned, hung up on joints, made it as far as the flooded c.b.
